**5010580 – CROYDON FRAS:  
REGINA ROAD 1-87 CONDITION  
SURVEY**

**MULALLEY & CO LTD**

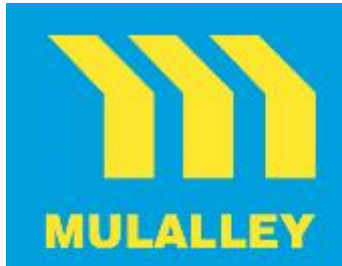
**5010580 - CROYDON FRAS: REGINA ROAD 1-87 CONDITION SURVEY**  
**MULALLEY & CO LTD**  
**27/04/2020**

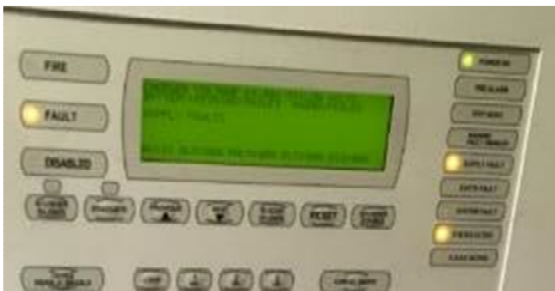
Figure 10 AOV control panel fault lights.

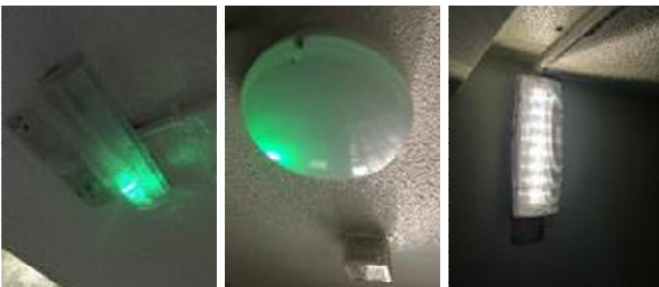
Figure 20 Typical emergency lighting.

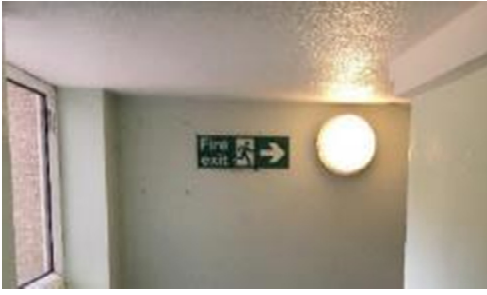
Figure 21 Ground floor rear corridor.

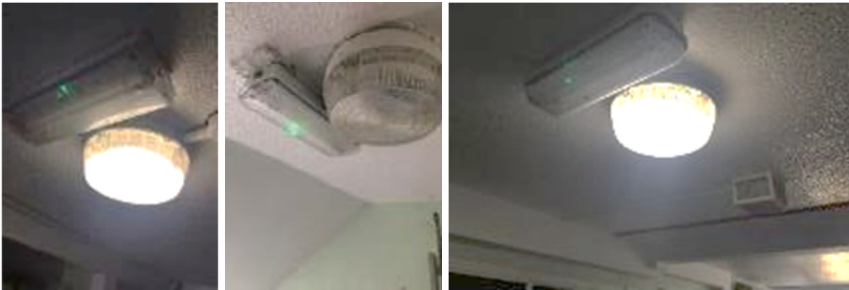
Figure 22 Ground floor rear corridor.

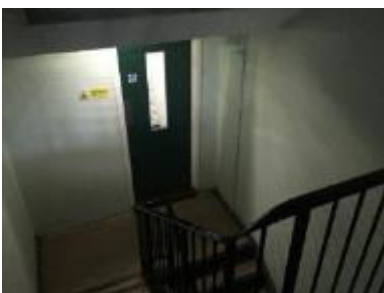
Figure 23 Stairwell with general lighting on.

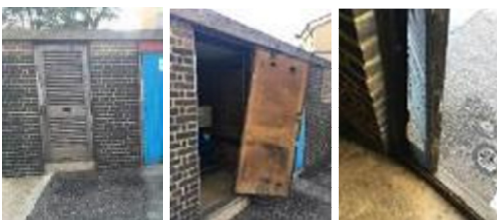
*Figure 33 Dangerous door.*

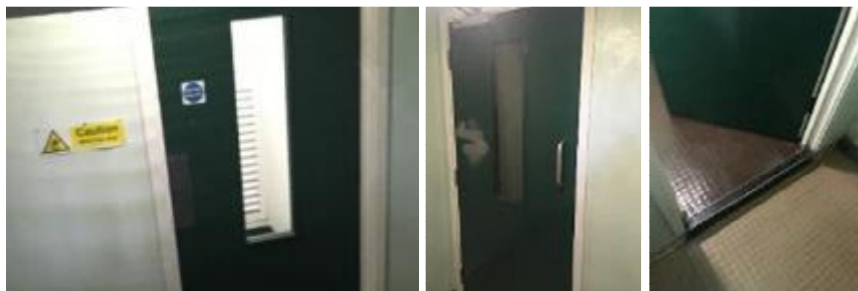
Figure 34 Step to the bin chute.

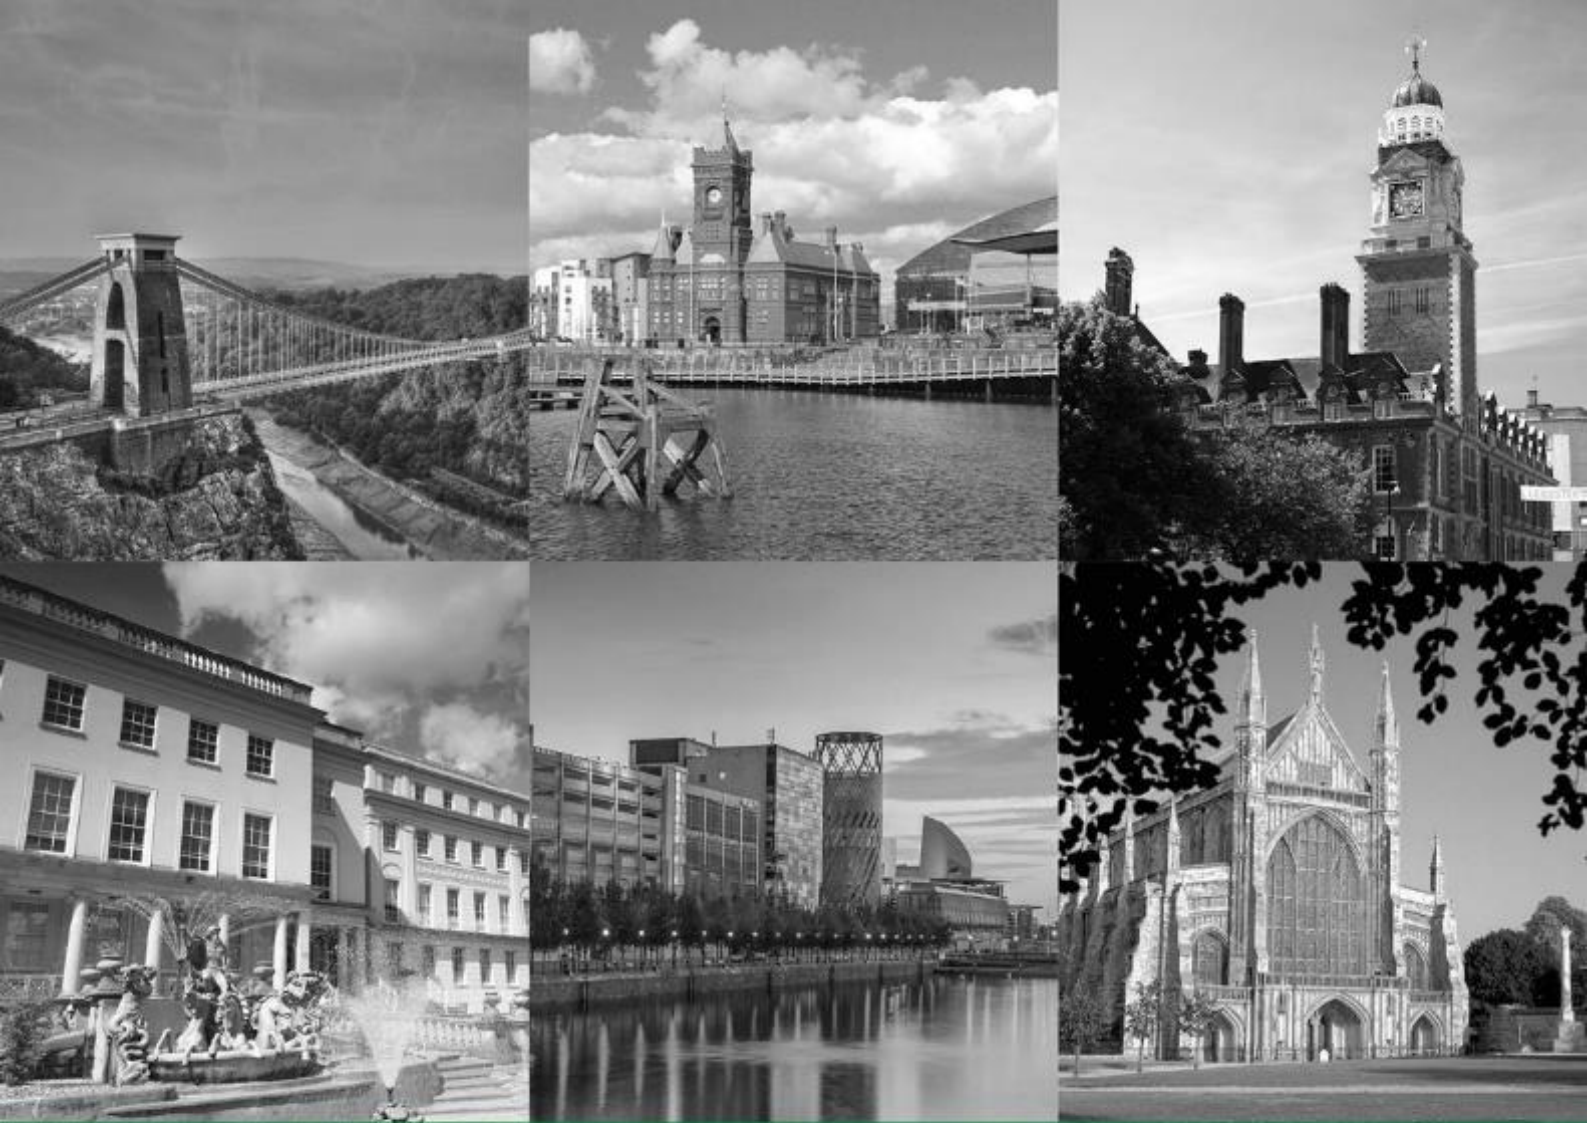
- In relation to item 1 in 10.1 assumes replacement of fire system cabling only
