**1 TO 87 REGINA ROAD
CROYDON LONDON SE 25 4TW**

**STRUCTURAL ENGINEERING
VISUAL INSPECTION OF TOWER
BLOCK**

August 2021

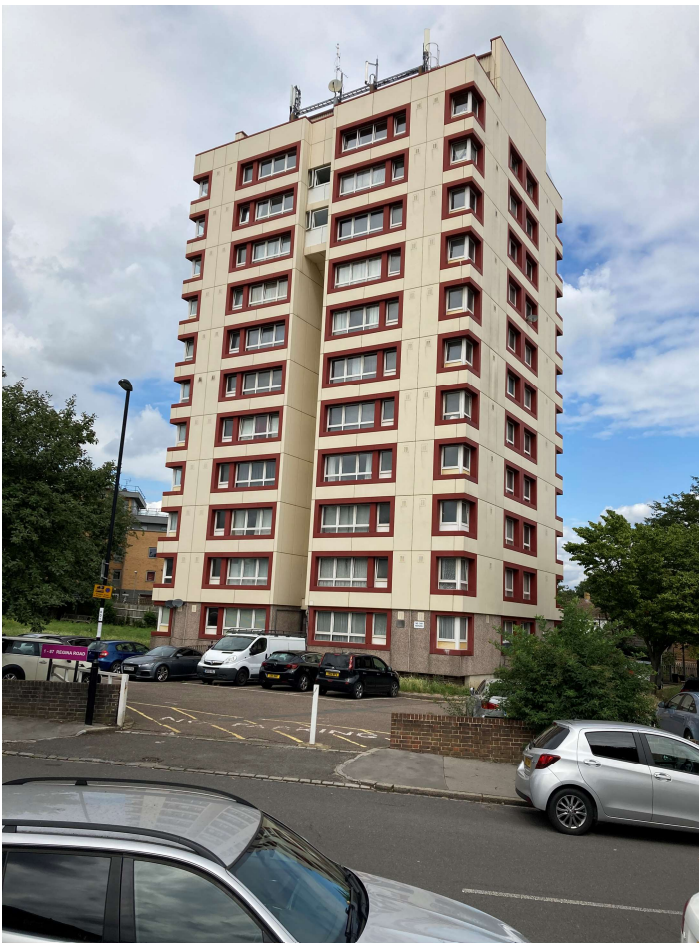
The building has subsequently been overclad, so the original cladding material could not be seen (refer Fig 1). The building contains four flats per level, symmetrically disbursed about a central stair and lift core. A projecting tower containing a waste chute has been added subsequent to the original date of construction to the north-western elevation (refer Fig 2).

Fig 1 View of Southeast elevation of 1 to 87 Regina Road

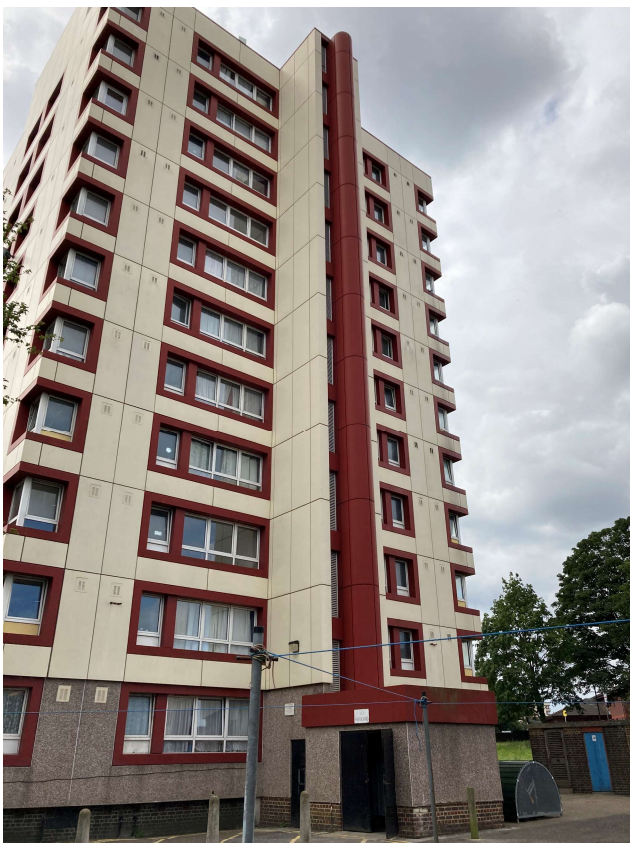
*Fig 2 View of Northeast elevation showing waste chute
Added after original construction*

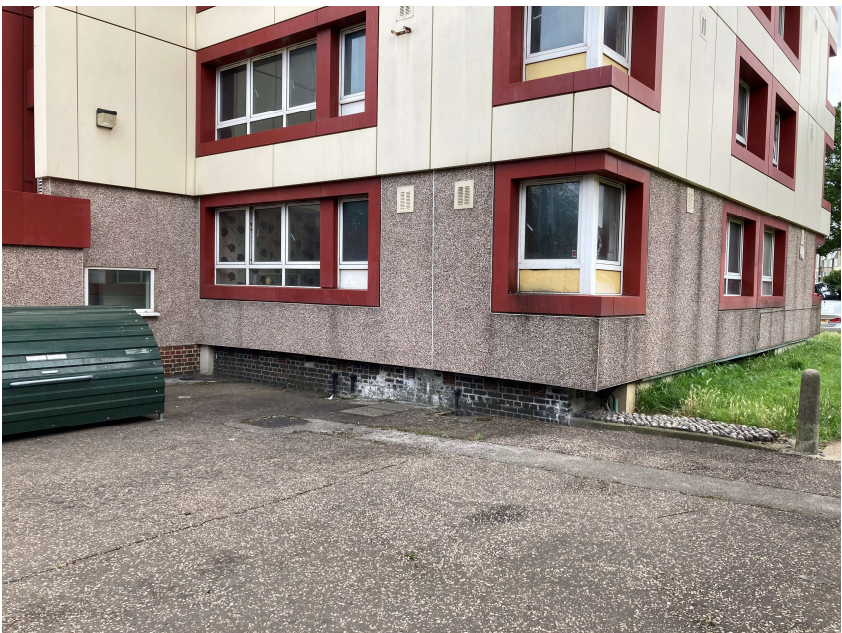
*Fig 3 Showing render finish to ground floor to over-cladding
and aluminium panels used for remainder of block*

Since the building had been overclad, the primary structure was hidden from view. Nevertheless, it was possible to see the brickwork enclosing the space below ground floor level, which remained exposed. This appeared to be in satisfactory condition (refer Fig 3).

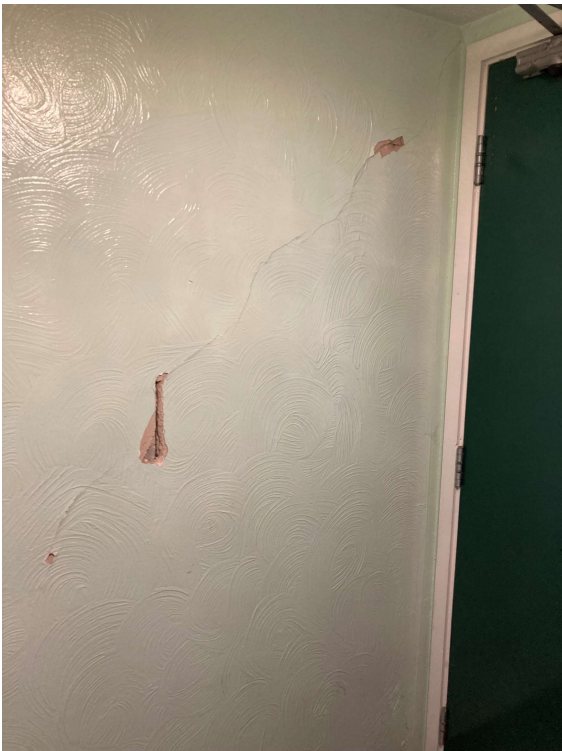
Internally the walls in the common areas had a plastered finish. There were one or two areas where the plaster had been damaged, but this was due to impact from door handles rather than because of any underlying structural issues. This had generated a diagonal crack parallel with the door handle in one wall believed to be of blockwork construction rather than LPS (refer Fig 4).

Fig 4 Diagonal crack in wall propagated through impact from door handle

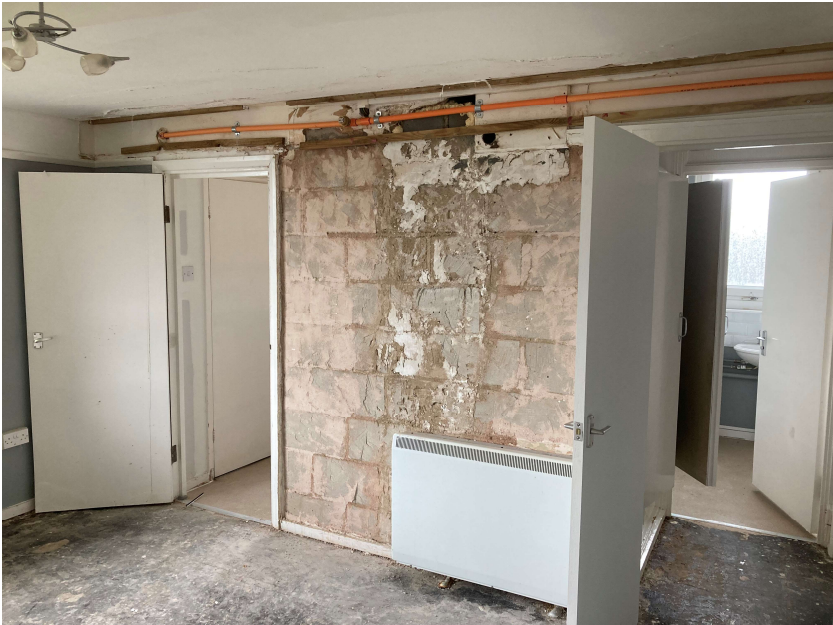
Within the flats that were examined, the internal partition walls were constructed in blockwork, (refer Fig 5) but the main structural walls all appeared to be of reinforced concrete large panels. This included the walls between the bedroom and bathroom and lounge and hall lobby.

Fig 5 Showing blockwork partition within flat

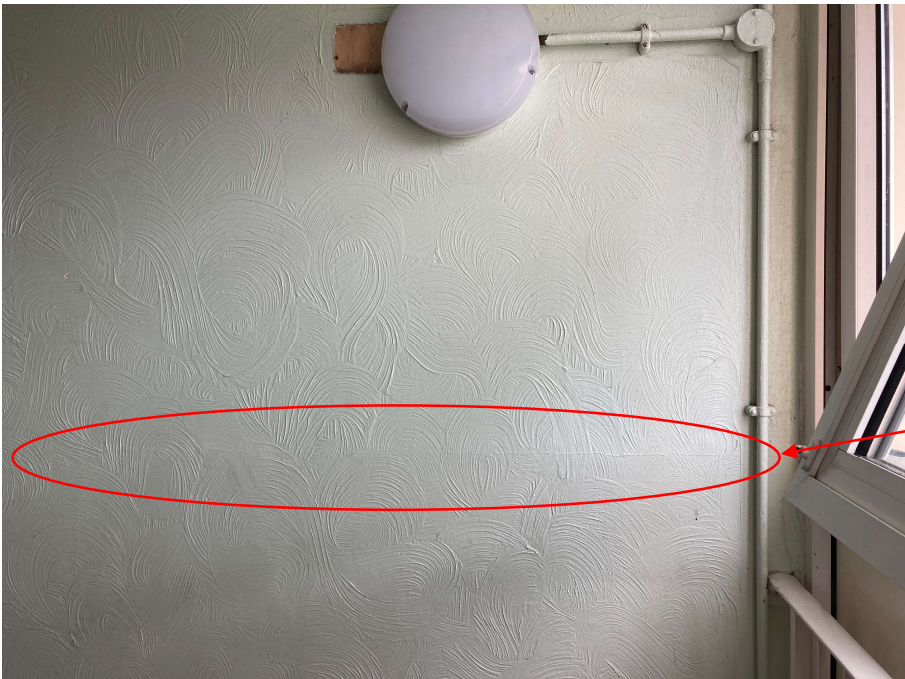
There were a few locations where the joints between the large precast concrete panels (both vertical and horizontal) were reflected in the plaster finish on these walls. However there was little evidence of any significant structural issues (refer Fig 6). There was no evidence internally of gaps appearing between wall and floor units, the floors did not appear to have suffered from long-term creep deflection, no longitudinal joints between adjacent units were visible, and there was no evidence of general cracking, exposed reinforcement or spalling concrete.

Barely visible line showing horizontal joint between LPS wall panels

Fig 6 Horizontal joint between wall units just visible in plaster

Taking the foregoing points into account, it is recommended that some sample areas are opened up in the voided units to allow visual examination of the joint details by a Chartered Engineer. This will enable an assessment to be made of whether the construction detailing and workmanship is likely to be of a satisfactory standard, sufficient to provide the degree of robustness required to resist disproportionate collapse. Whilst such a limited scope investigation will only allow a very small sample to be considered, it will provide an indicator as to the standard of construction employed on the remainder of the building, and hence enable an informed decision to be made on whether furthermore detailed investigation might ultimately be necessary.
