**2-56A REGINA ROAD  
CROYDON LONDON SE25 4TU**

**STRUCTURAL ENGINEERING VISUAL  
INSPECTION OF TOWER BLOCK**

24<sup>th</sup> September 2021

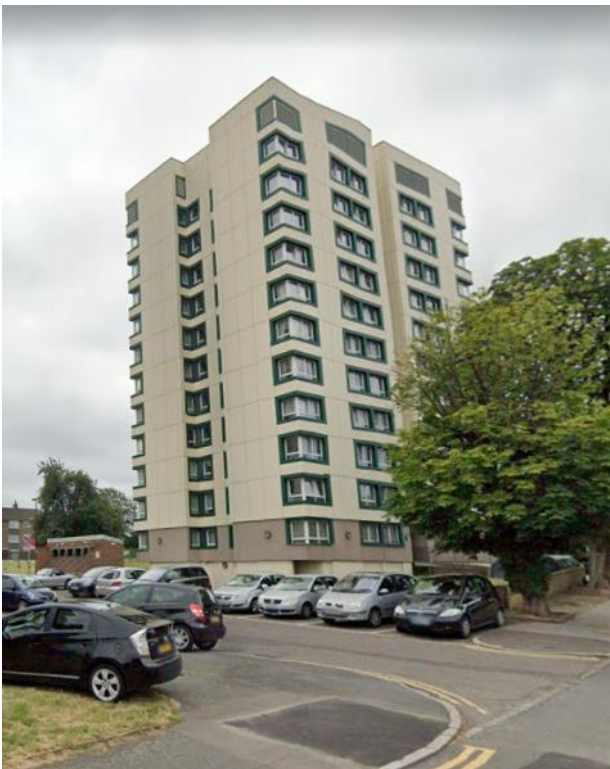
*Fig 1 View of South and West elevations of 2-56A*

The tower has subsequently been overclad, so the original cladding material could not be seen (refer Fig 1). The record drawings provided by LB Croydon (by Harley Curtain Walling) are for the over cladding works at 2-56A Regina Road and Regina Road Blocks, which are identical in layout and appearance. The drawings are dated July-September 2002 (refer example in Fig 2).

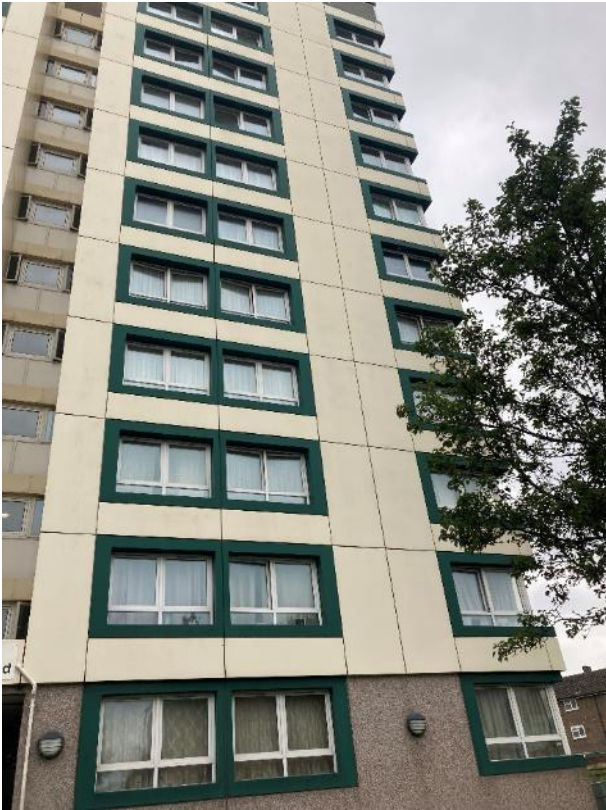
*Fig 5 Southern elevation 2-56A showing render finish to ground floor to over-cladding and aluminium panels used for remainder of block*

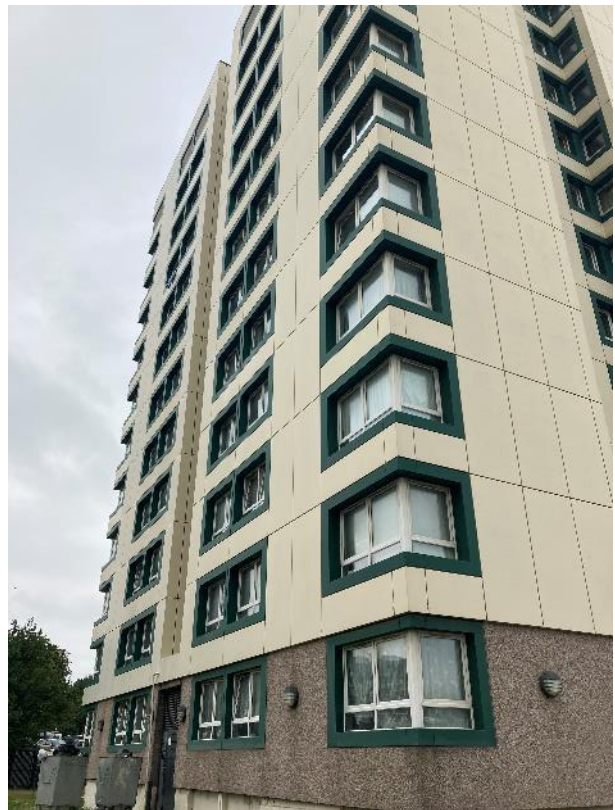
*Fig 6 View of Northern elevation 2-56A*

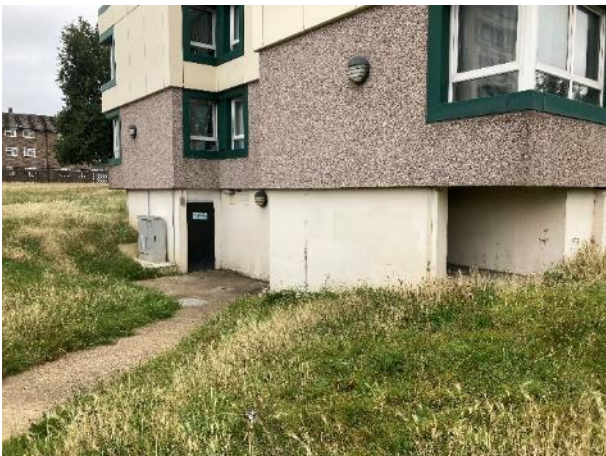
*Fig 7 Low level south-eastern elevation 2-56A Showing render finish to ground floor to concrete and brick substructure*

Since the building has been overclad, the external primary structure is hidden from view. Nevertheless, it was possible to see the brickwork and concrete supporting the tower and enclosing the space below ground floor level, which remains exposed. This appeared to be in a generally satisfactory condition (refer Fig 7 and 8).

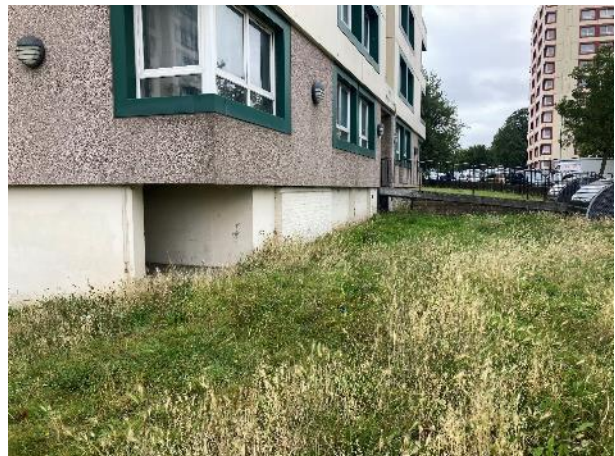
*Fig 8 Low level south-eastern elevation 2-56A Showing render finish to ground floor to concrete and brick substructure*

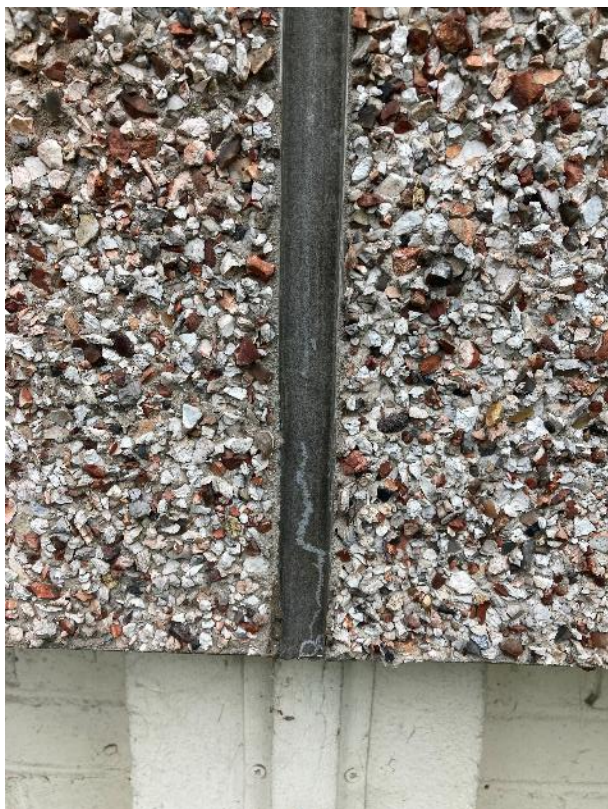
*Fig 9 Close up of vertical joint between panels*

An external joint in the rendered panel was also examined from ground level. This looked in good order with the infill material remaining flexible and fully filling the joint (refer Fig 9).

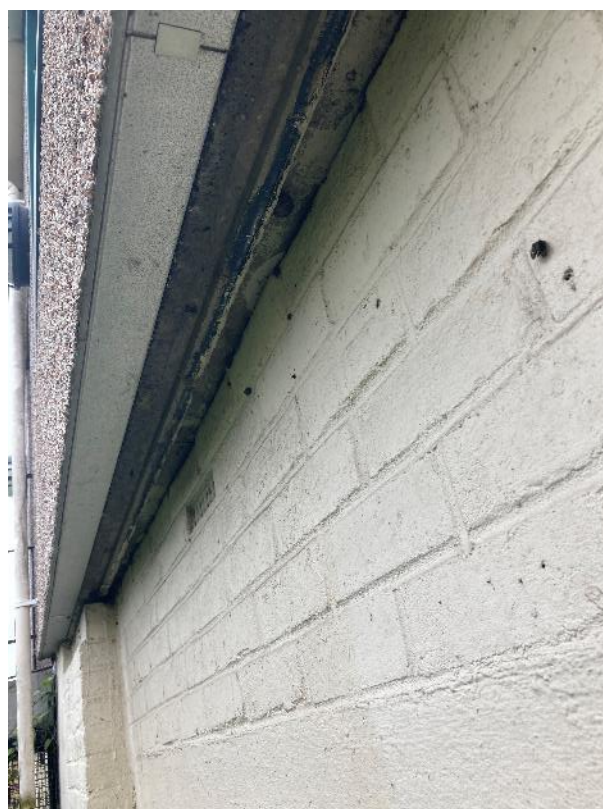
*Fig 10 Underside of rendered concrete panel at ground floor level*

The underside of an external panel was also inspected. This shows the render on a layer of insulation as indicated on the record drawings which is fixed onto the concrete panel (refer Fig 10). The underside of the panel looked relatively sound with no cracks, spalling or exposed reinforcement.
