**2-56A REGINA ROAD  
CROYDON LONDON SE25 4TU**

**STRUCTURAL ENGINEERING VISUAL  
INSPECTION OF TOWER BLOCK**

24<sup>th</sup> September 2021

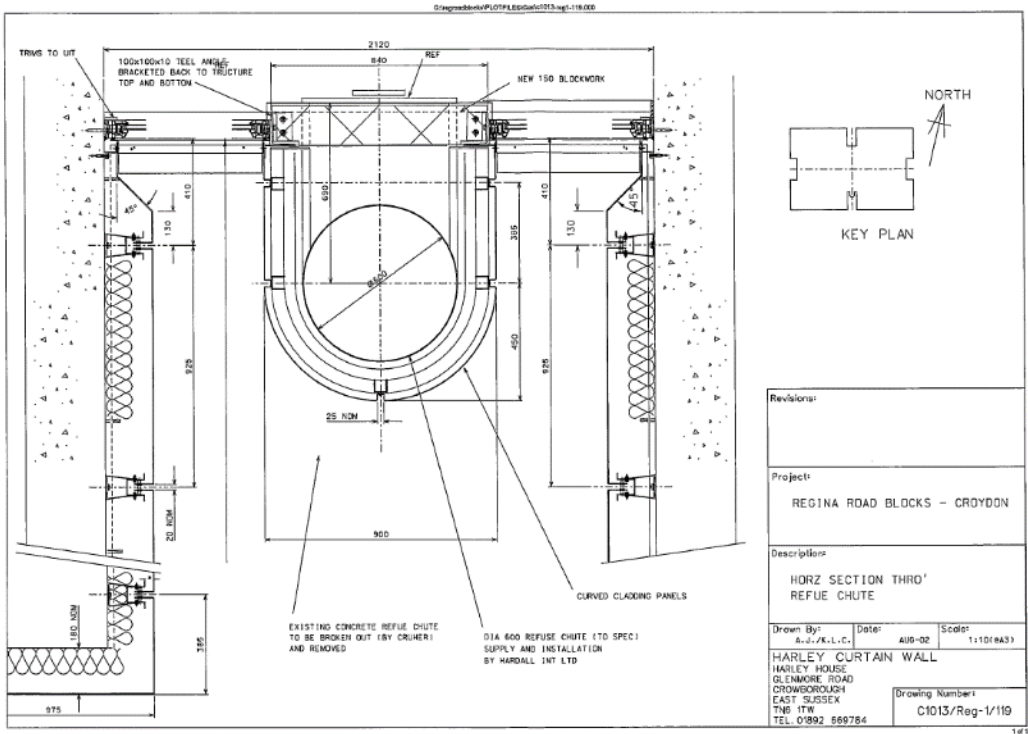
A projecting waste chute is visible to the rear of the tower, located in a recess adjacent the central core. It appears from the record drawings that the original chute was broken out and new added during the over cladding works (refer Fig 3).

Fig 3 Over cladding record drawings for 'Regina Road Blocks' dated Aug. 2002 showing proposed refuse chute

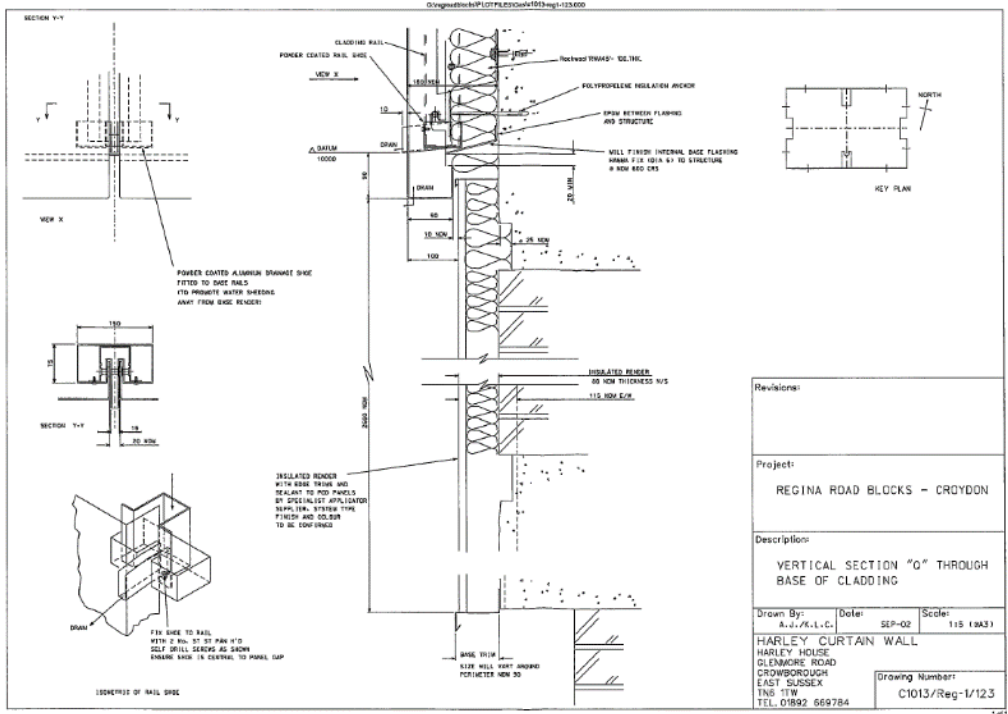
The record drawings show the cladding system comprised of brackets fixed to the concrete structure supporting a system of vertical rails to which aluminium cladding panels have been fixed. This had been applied from first floor level up to roof (refer Fig 4).

Fig 4 Over cladding record drawings for 'Regina Road Blocks' dated Sept. 2002 showing detail at ground floor
